## SPACE STATION SOLAR ARRAY JOINT REPAIR

**ABSTRACT:** In Oct 2007 the International Space Station (ISS) crew noticed a vibrating camera in the vicinity of Starboard Solar Alpha Rotary Joint (SARJ). It had less than 5 months of run time when the anomaly was observed. This ~3.2 meter diameter bearing joint supports solar arrays that power the station critical to its operation. The crew performed an EVA to identify what was causing the vibration. It was discovered that one of the 3 bearing tracks of this unconventional bearing had significant spalling damage. This paper discusses the SARJ's unique bearing design and the vulnerability in its design leading to the observed anomaly. The design of a SARJ vacuum test rig is also described along with the results of a life test that validated the proposed repair should extend the life of the SARJ a minimum of 18 years on-orbit.

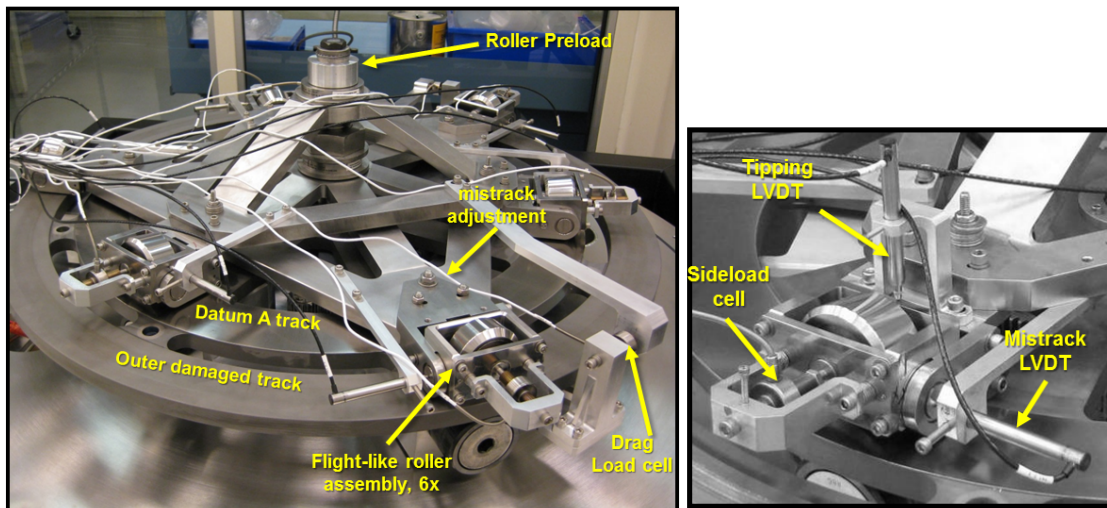
**Test Rig Description:** The SARJ LITE tester uses a flight-like, nitrided race plate with dual track surfaces to simulate the damaged (outer 45°) and undamaged flight races (Figure 8). The outer track was artificially damaged using a friction-stir welding machine and it and the inner track were lubricated with Braycote 602 flight grease using the proposed flight lubrication process (see Figure 9). Note that the intergranular network within the nitrided case of the SARJ test plate, believed similar to the Port SARJ, was less extensive (~ 80% less area) than the Starboard [4]. However the pre-test damage

The test rig track diameter was scaled down in size by a factor of 3 to comfortably fit inside a custom vacuum chamber. Three, well instrumented, full size trundle roller assemblies contacted each test track. They were supported by an inner and outer spider which provided flight preload and flight-like roller spacing. Rollers have flight diameters, materials, hardness, surface finish and profiles plus they were preloaded at flight preload levels. The race plate was supported by a set of 3 cam follower rollers for each track. The support rollers were mounted directly underneath the plate in line with the trundle roller to react the contact load with minimal deflection. The rotating drag torque of each of the roller sets (45° outer and Datum A) was measured independently by a load cell-instrumented torque arm (Figure 8).

Figure 8 also shows a close up view of the trundle roller assembly instrumentation. Each roller is equipped with a thrust load cell to monitor side traction loads, a measure of the quality of the lubrication between the roller and the race. Increases in side load is a direct measure of an increase in the contact friction coefficient. The rollers were intentionally misaligned at angles that were slightly larger than flight using the “mistrack” LVDT. The roller cradle had a camber pivot which allowed the roller to tip as measured by a “tipping” LVDT. Rollers were preloaded against the race at flight levels. These parameters were recorded and trended through the test as an indicator of lubrication health.

**Figure 8 SARJ LITE test rig showing Outer 45 damaged track and undamaged datum A track each contacted by three well-instrumented flight-like roller assemblies .**

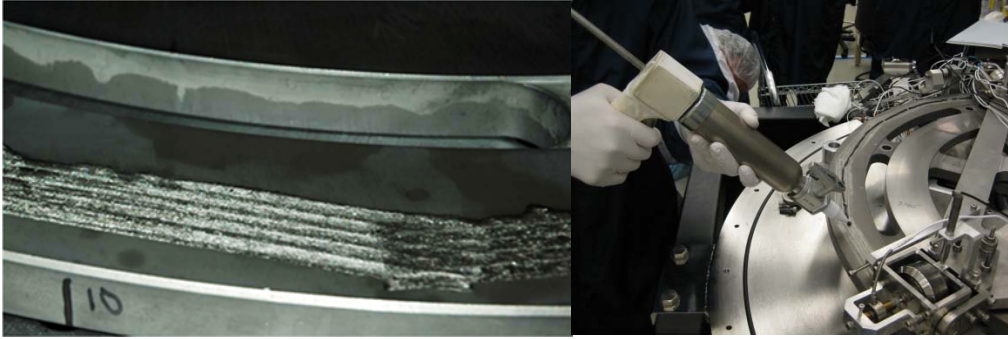
inflicted into the outer 45° test track was intentionally more severe than observed on-orbit to help compensate for this.

**Figure 9: Predamaged Outer 45°Race which was lubricated using the flight process**
